Application of Electroluminescence and Thermal Imaging in Defect Identification in Photovoltaic Modules

J L Crozier*, E E van Dyk and F J Vorster

Nelson Mandela Metropolitan University, Port Elizabeth, South Africa

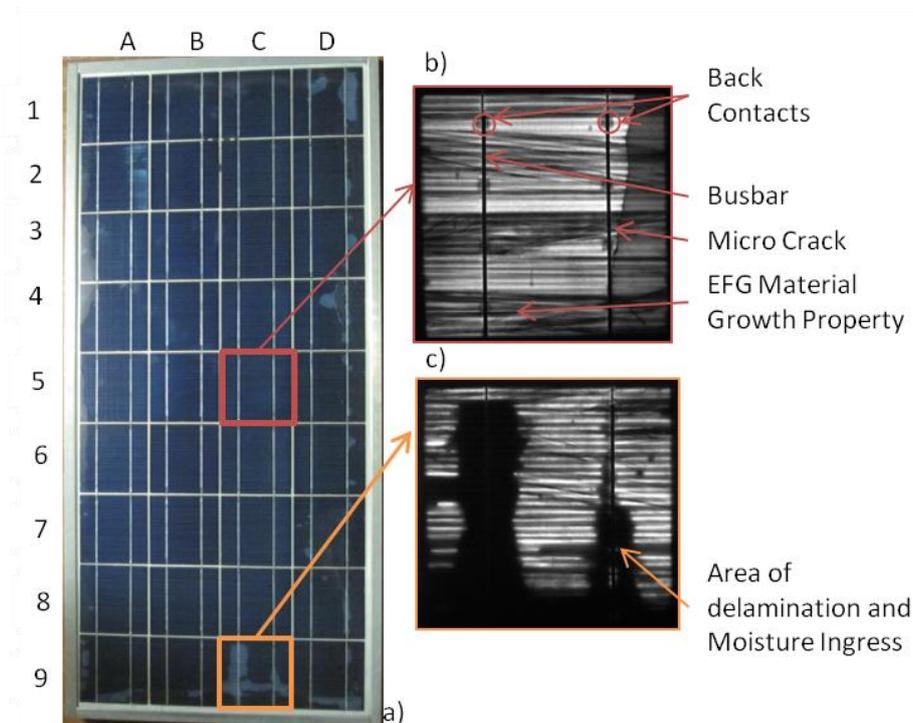
The EFG module has delaminated allowing air and moisture to infiltrate between the encapsulant around the sides of the module. Figure 2(a) shows the optical image of the EFG module with cells C5 and C9 indicated. Figure 2(b) and 2(c) show the EL images of the C5 and C9 respectively.

Despite there being no optically visible damage to cell C5, the EL image shows that the cell has cracked. This crack decreases the electrical contact to a portion of the cell and thus lowers the intensity of the EL signal. The nature of the EFG growth process results in non-parallel variations in the cell material which are visible in the EL image. The eight back contacts that are present in each EFG cell are visible as areas of lower EL signal intensity. This is due to the high collection efficiency in these areas due to the back contact.

Cell C9 is severely affected by delamination which has spread along the busbar and affects about half of the cell. The EL image shows very low signal intensity over the areas of the cell affected by delamination meaning that the exposure to moisture has degraded the cell material and what little luminescence that is produced is blocked by the encapsulant discolouration.

Figure 2. (a) Optical image of EFG module with cells indicated. (b) EL image of cell C5 with defects highlighted, (c) EL image of cell C9 showing the effect of delamination.

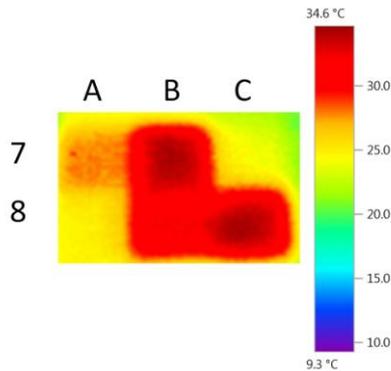
Figure 3 shows the infrared image of the bottom-right corner of the EFG module under short circuit conditions. A hot spot is visible over cell C9. This suggests that cell C9 is a poor current producing cell. This supports what is seen in the optical and EL images.

Figure 3. Infrared image of a portion of the EFG module.

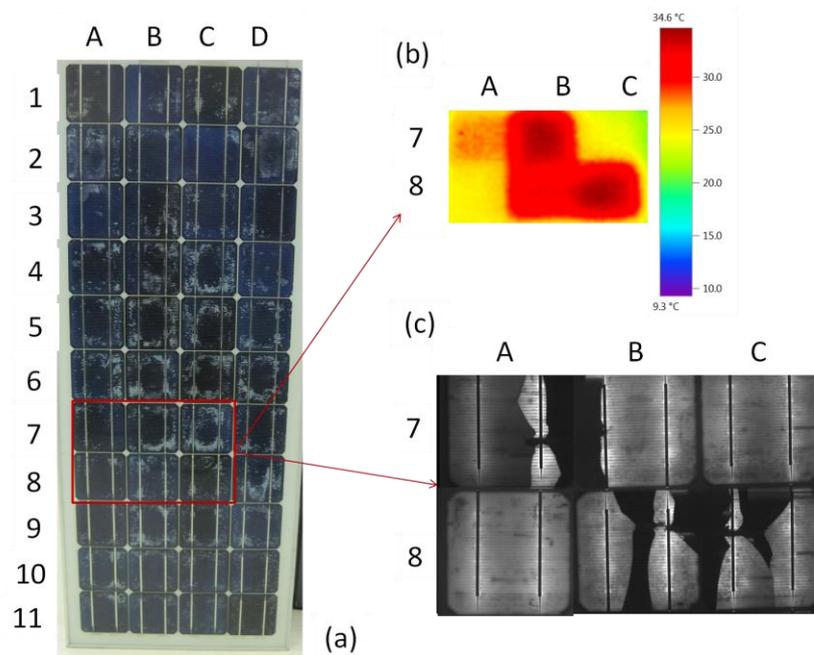
Figure 4(a) shows an optical of the single crystalline module with the damaged cells highlighted.

The infrared image of the single crystalline silicon module under illumination and in short circuit connection is shown in figure 4(a). The EL image of the damaged cells is shown in figure 4(b). The hot-spot indicates poorly performing cells which are reverse biased and heat up. The cells identified as poorly performing cells are A7, B7, B8 and C8. The EL images of these cells indicate that they appear to have cracked. Figure 5(a) shows an optical image of these cells with defects highlighted. Figure 5(b) shows scratches on the back of the module. Figure 5(c) shows a magnified image of damage on cell C8. Scratches on the back of the module correspond with features observed in the EL image. These cracks most likely occurred due to some mechanical damage. Scratches on the back of the module suggest that the module might have been dropped or hit with some force. The cracks remove portions of the cell from electrical contact and thus the carriers are not injected into this region and thus no luminescence occurs in these areas. These four damaged cells probably contribute greatly to the decreased performance of the module but would not have been easily detected without using EL.

The silver grey discolouration present in this module is most likely due to degradation in the silver nitride anti-reflective coating. The areas of discolouration have a varying effect on the EL signal intensity. Degradation in the anti-reflective coating may not affect the performance of the cell material in that area but rather block the luminescence so that it is not detected from that area. The areas affected by the reflective coating degradation thus affect the photoresponse of the cell material.

Figure 4. (a) Optical image of the single crystalline silicon module with damaged cells highlighted. (b) Thermal image of portion of module under illuminated, short-circuited conditions. (c) EL image of damaged portion of module

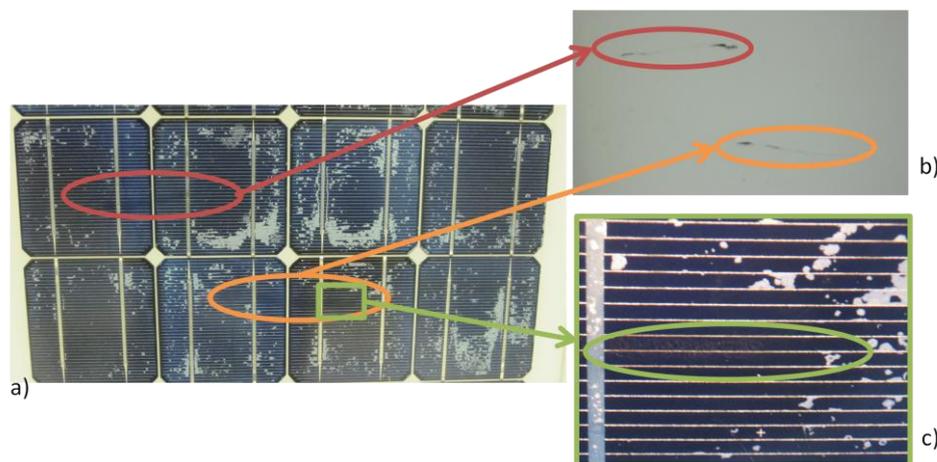
Figure 5. a) Optical image of damaged cells with defects indicated. b) Optical image of back of modules with scratches, c) close-up image of damaged area of cell with visible damage to cell material
