Introduction

- Thermal infrared (TIR) images of operational photovoltaic (PV) modules are generally misinterpreted because of the dynamic nature of some types of soiling.
- TIR imaging is ideally conducted under steady climatic conditions, however under dynamic operational conditions different TIR images are observed.
- Wind blown dust is dynamic in nature and can settle on the bottom rows of PV modules.
- Cell anomalies, partial soiling and defective cells, can cause current mismatch in crystalline silicon PV modules and create hot spots which can be detected on TIR images.
- Mismatched cells impact on performance and longevity of PV modules.

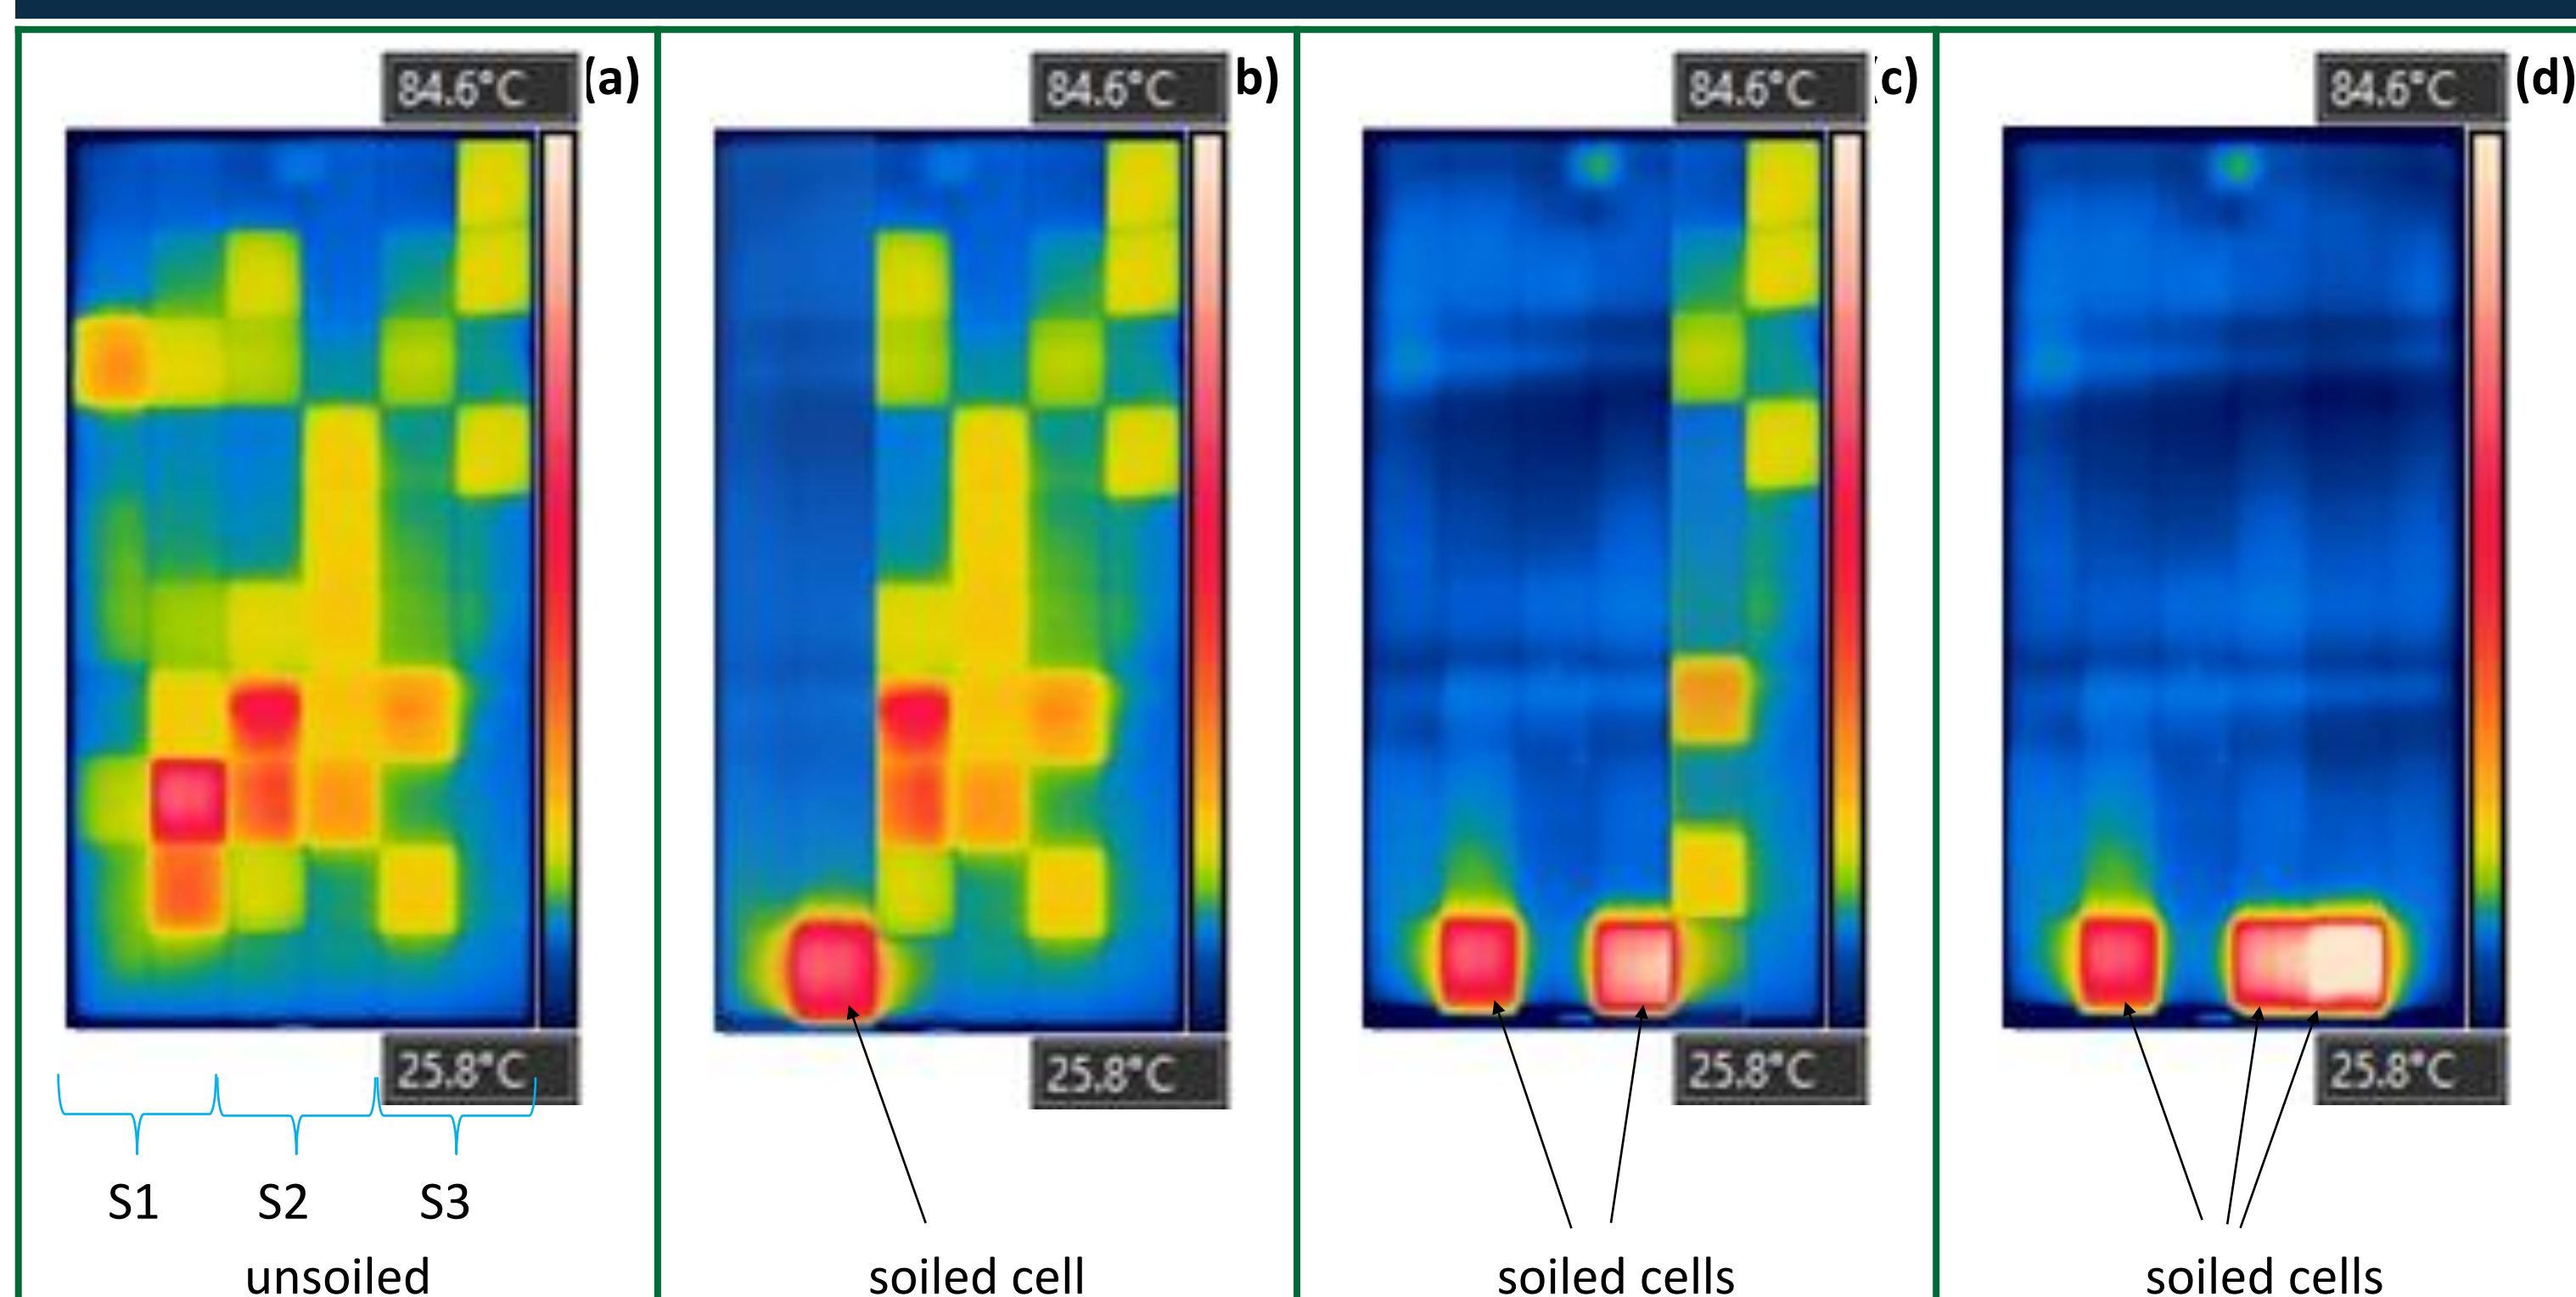
Fig 2: TIR images of the crystalline silicon PV module captured under short circuit and different soiling conditions.

- Non-uniform temperature distribution is observed on TIR image of the unsoiled module, Fig. 2(a), with the hot cells displaying a patchwork pattern in substrings S1, S2 and S3.
- When a good cell in S1 is shaded by partial soiling (<10%), it operates at an abnormal temperature, while the rest of the substring cells operate at uniform temperature, Fig. 2(b).
- The dynamics of thermal signatures is also observed when two and three cells in S2 and S3 were similarly partially soiled sequentially, as shown in Figs. 2(c) and 2(d).
- Partial soiling minimises current mismatch in the substrings resulting in the bad cells appearing as good cells on TIR image, Fig. 2(d).

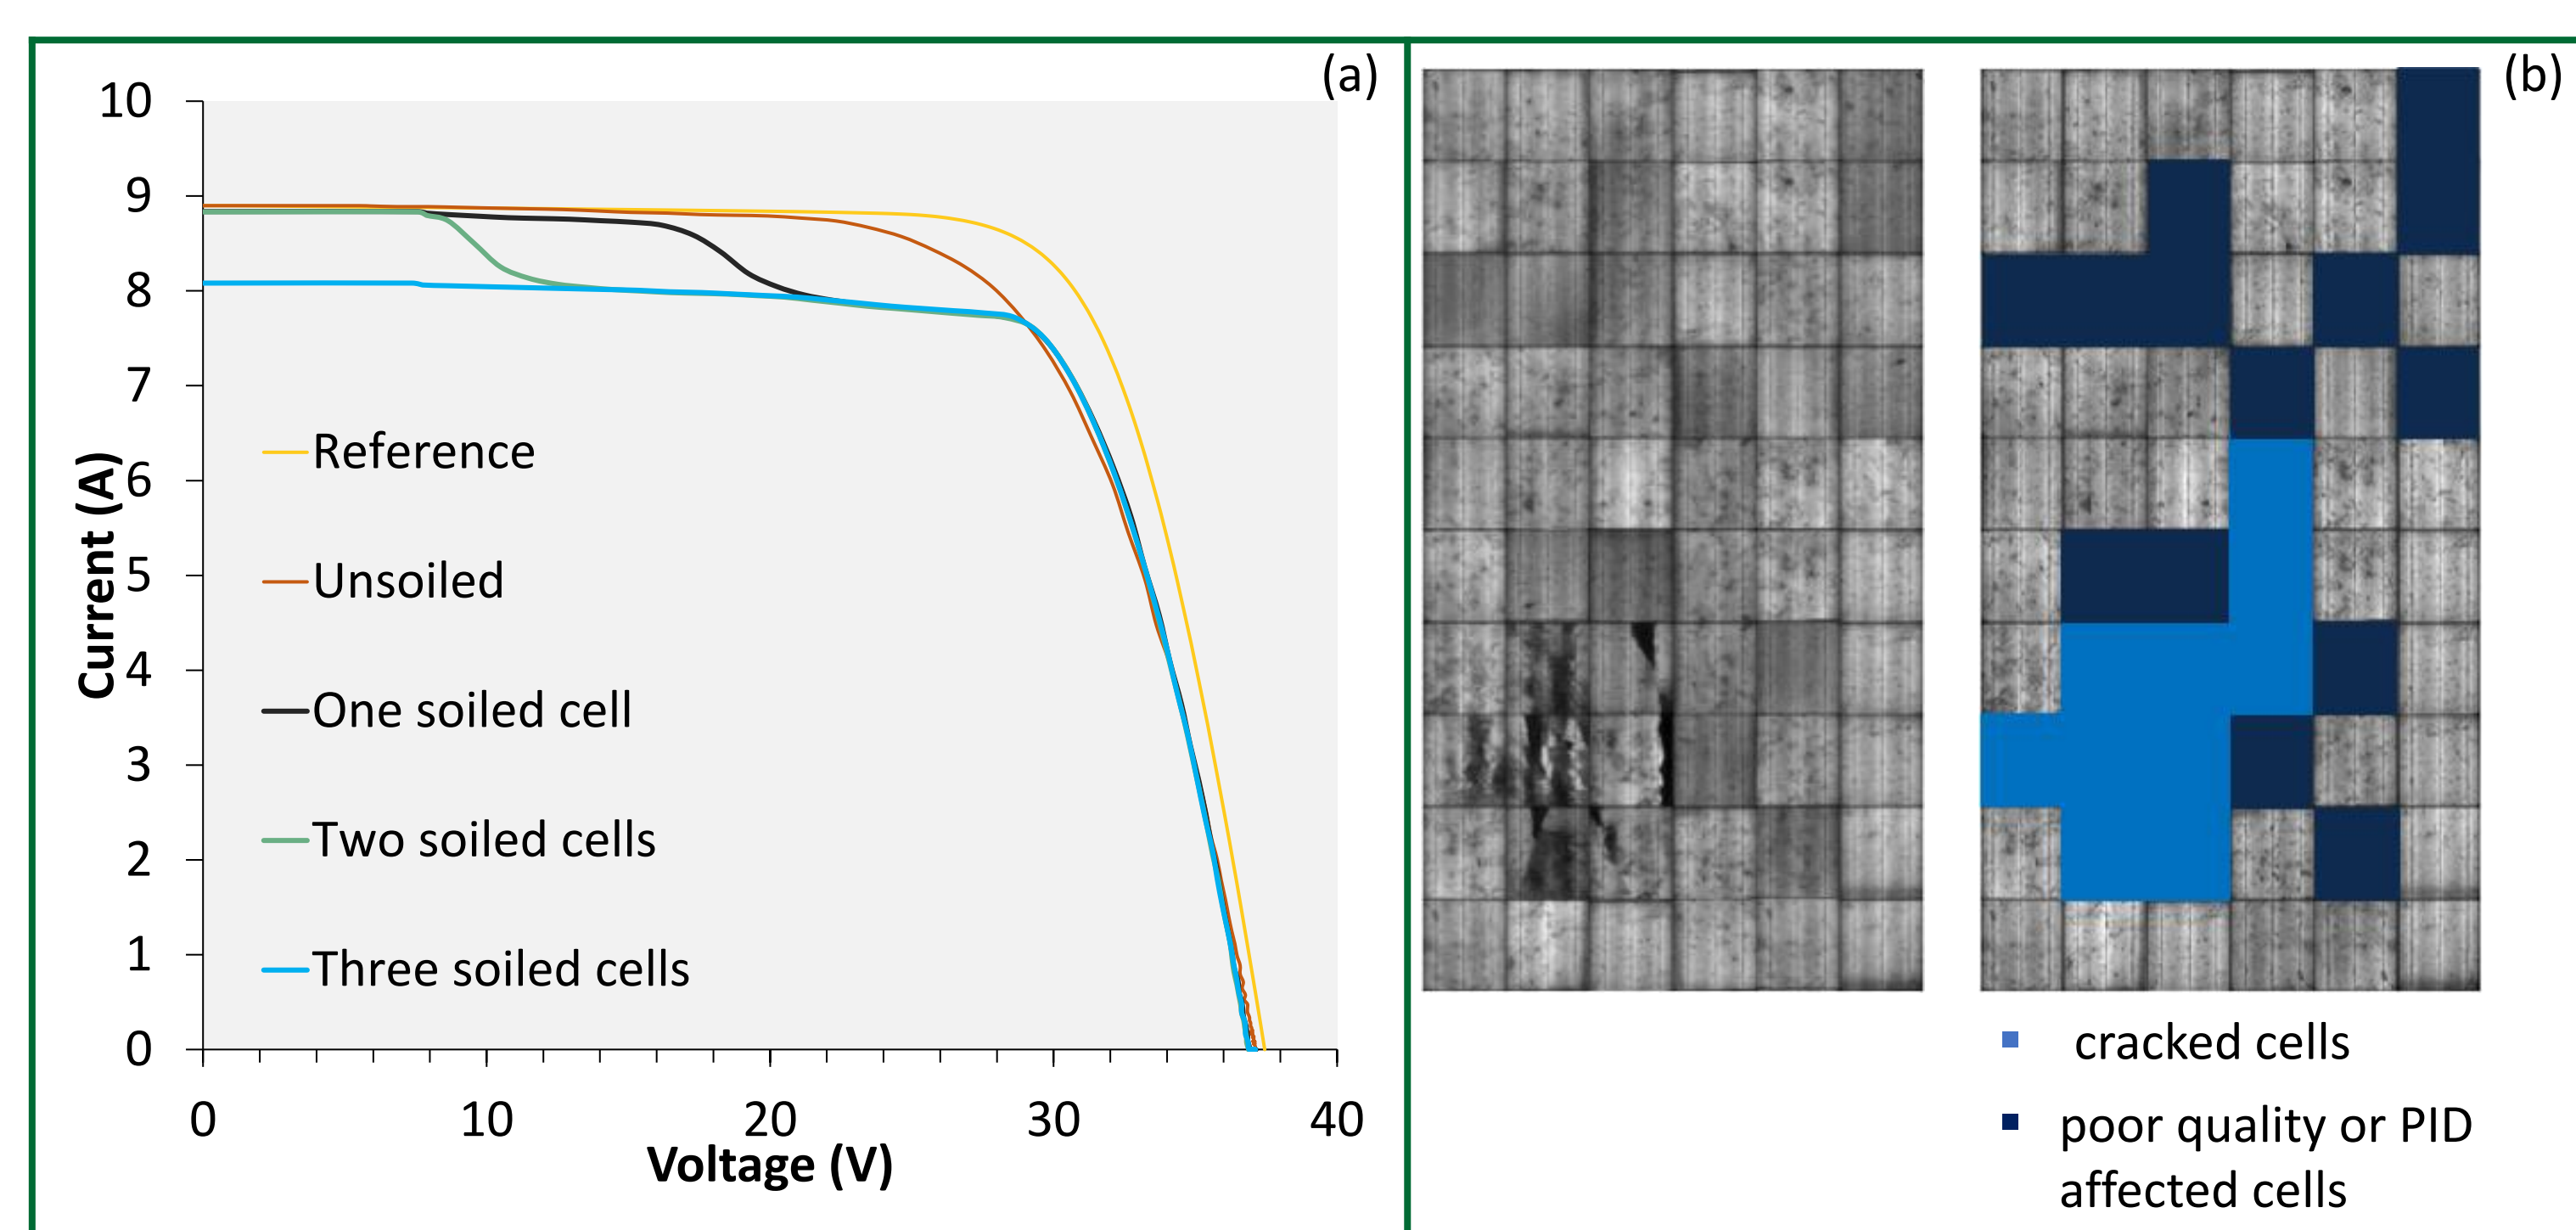
Fig 3: (a) I-V characteristics and (b) EL images of the crystalline PV module.

- The I-V curve of the unsoiled module deviated from the reference I-V curve, generated in PVSIM, for voltages higher than 20 V due to cell anomalies which also caused a reduction in V_{OC} of ~ 0.5 V.
- Partial soiling created bumps on I-V curves reflecting active bypass diodes.
- When three cells in different substrings were partially soiled uniformly, no bypass diode was active hence no bump is seen in the I-V curve, but a drop in module's in I_{SC} .

- The EL image, Fig. 3(b), reveals that some hot cells in Fig. 2(a) that were identified when the module was unsoiled correspond to damaged cells and other hot cells were due to Potential Induced Degradation (PID) affected or poor quality cells.
- The damaged cells operated normally and appeared as good cells, on TIR imaging, when the substrings S1, S2 and S3 were partially soiled.
- In-depth knowledge on the state of the cells can be obtained by incorporating EL imaging.

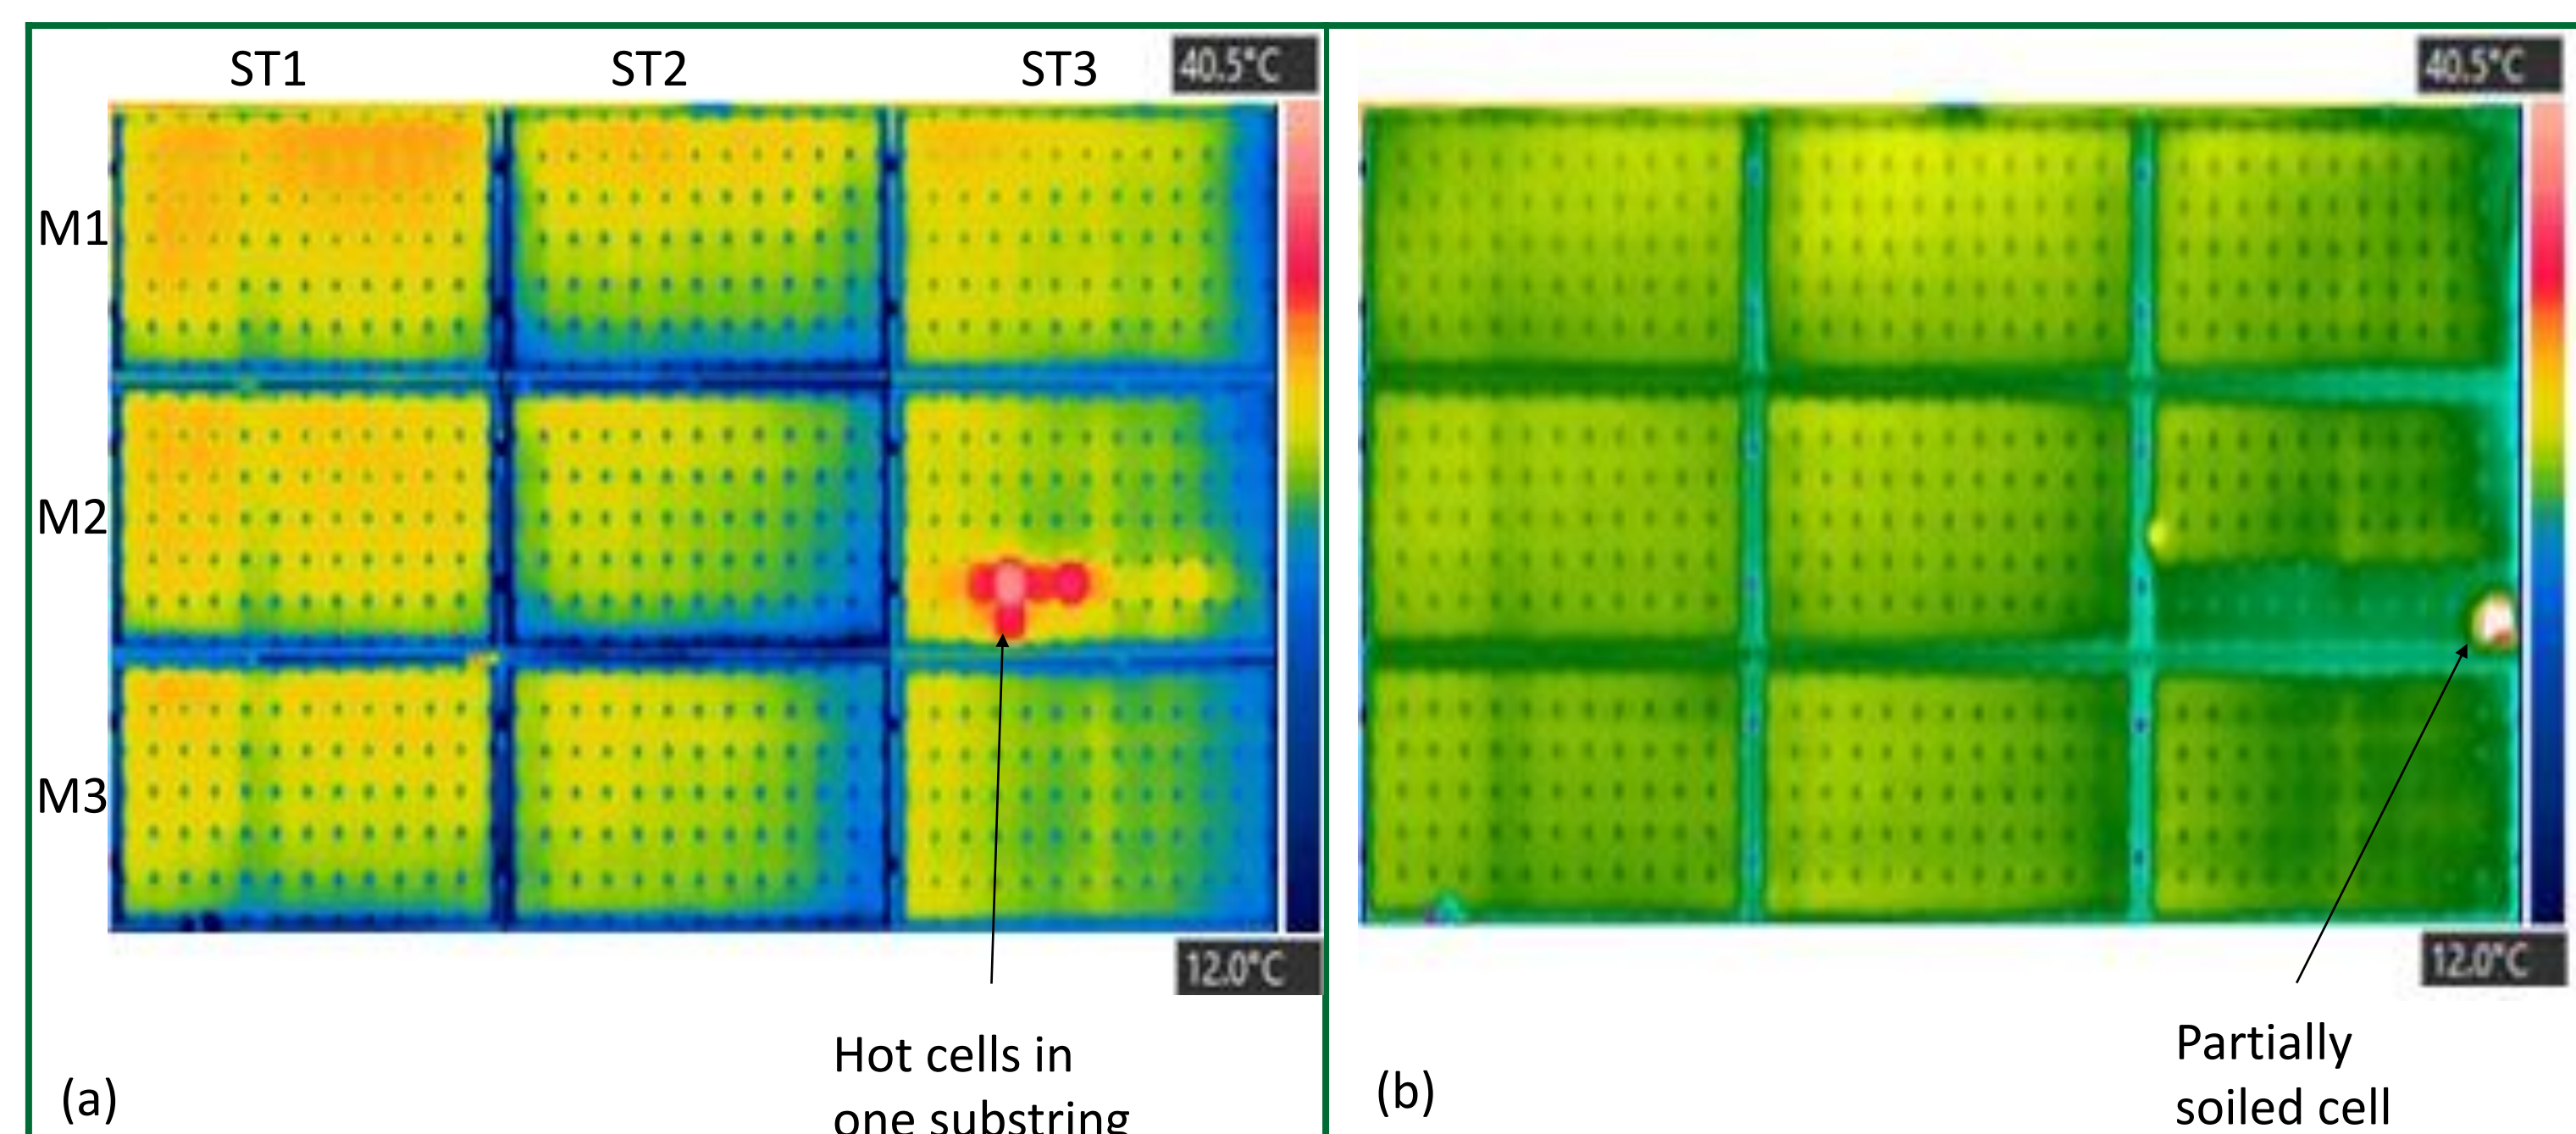
Fig 4: Thermal images of the monocrystalline array when (a) unsoiled and (b) partially soiled.

- Fig 4(a) shows non-uniform temperature distribution in the plane of array that was caused by several abnormally hot cells in one substring.
- The problematic cells were underperforming and were mismatched with good cells, forcing the bad cells to operate at elevated temperature.
- When one cell in the array was partially soiled (<10%), Fig. 4(b), the whole cell heated up mainly due to current mismatch when the cell was operating in reverse bias.
- The bad cells in the soiled substring could not show their abnormal thermal signature due to partial soiling.
- Partial soiling influence current mismatch in operational crystalline modules and affect results on TIR images.
- Partial soiling can mislead, during PV inspections, to only cleaning the dirty modules yet other anomalies are hidden.

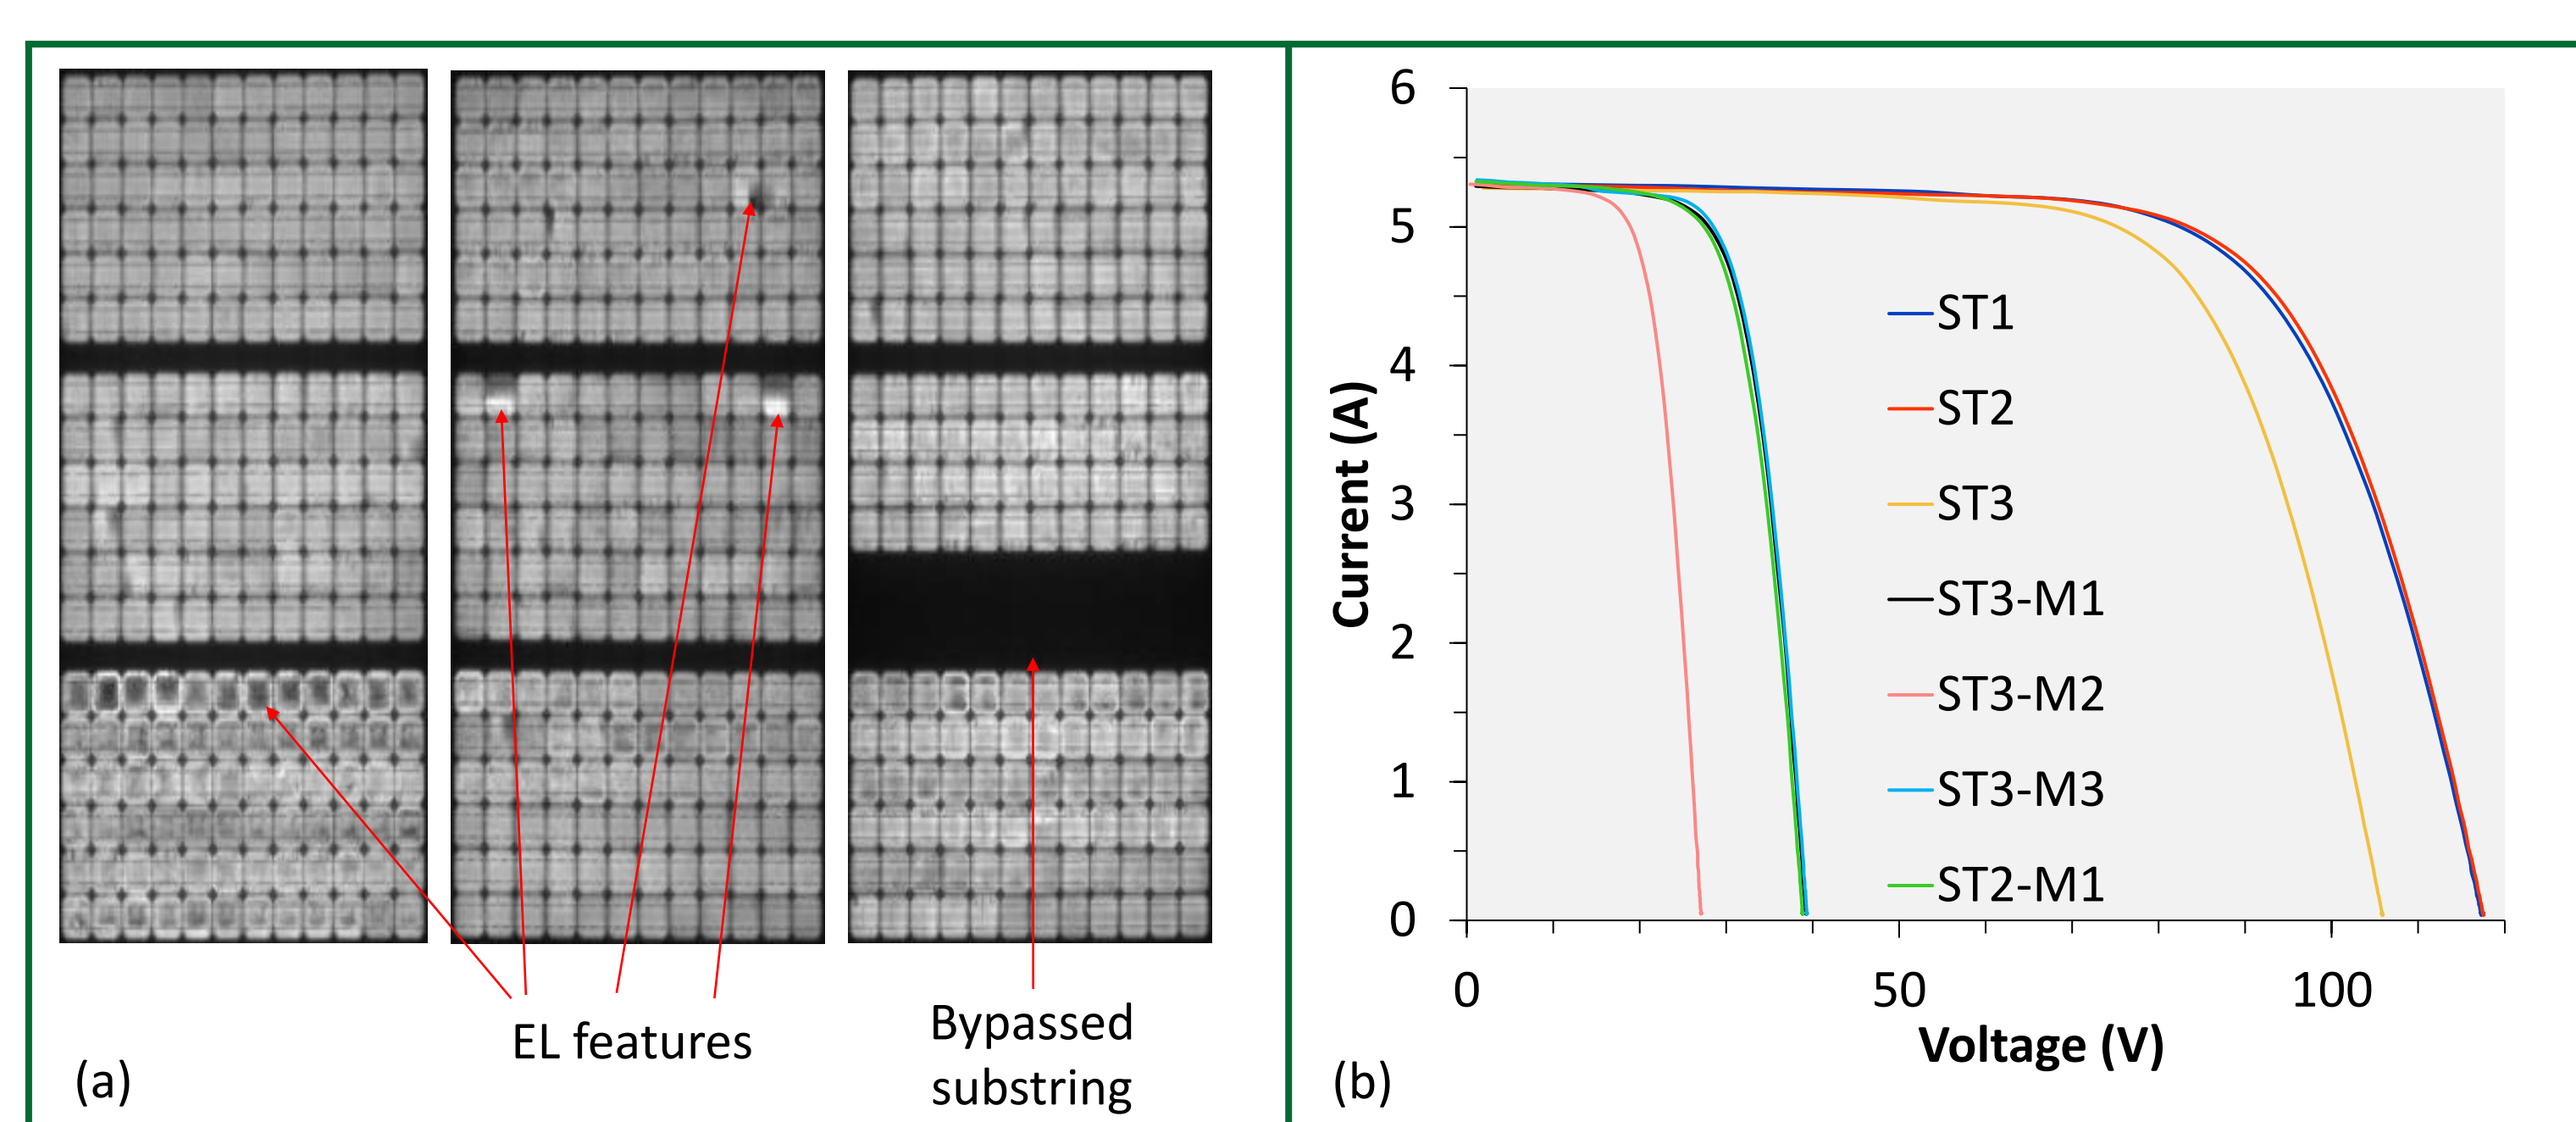
Fig 5: (a) EL image and (b) I-V characteristics of the monocrystalline array.

- EL and I-V measurements reveal that one substring is problematic.
- Other EL features could not cause significant current mismatch to appear as hot spots on TIR images.
- The substring appears dark since it was bypassed when the string ST3 was biased for EL imaging.
- The abnormalities in the substring caused a drop in V_{OC} of ~ 12 V between good and bad strings and modules, and resulted in power loss of 18% on module level which translate to 9% on string level, indicated in Table 1.
- No bump on the I-V curves of the underperforming string ST3 and module ST3-M2 since the bypass diode across the substring is faulty (shorted).
