Earth Stewardship Science Research Institute

Low-level river crossings and erosion repair of the access road for general ease of access and secure transportation of the Lunar Laser Ranger and radio telescope equipment to the Matjiesfontein Space Geodesy Observatory

Cornel Janse van Rensburg¹, Leon Croukamp²

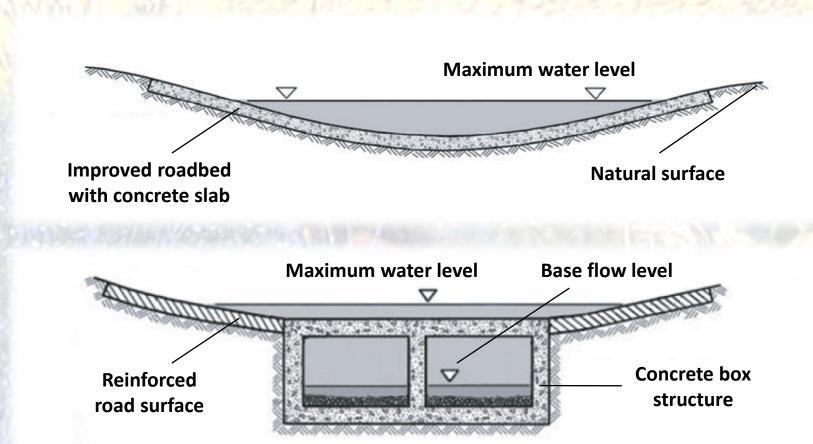
At-grade (top) and box vented (bottom) fords

From the hydraulic calculations, at-grade fords are recommended for crossing 1 and crossing 3, and a box vented ford for crossing 2. Construction of the crossings should be carried out during the dry season when the water level is low or preferably when it is dry. Due to the concrete having to cure for at least seven days it is recommended that the construction team should start with crossing 3 and work back towards Matjiesfontein. This will enable the construction team to start working on crossing 2 without having to wait for the concrete slab of the first crossing to cure. The same applies for crossing 1.

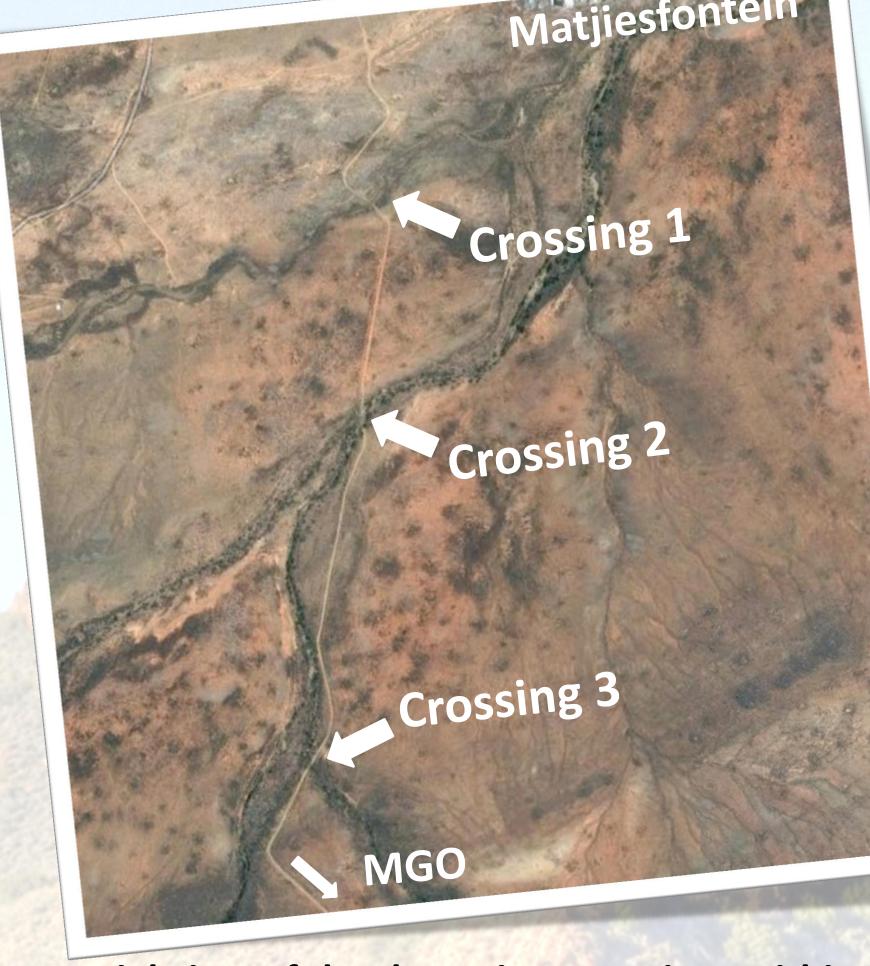
There are currently no structures to allow for safe and reliable passage at any of the crossings and therefore low-level river crossings have to be designed for the first three as seen on the picture to the right. The crossings should ensure access to the MGO at all times, including the rainy season.

Aerial view of the three river crossings within section 1 of the access road

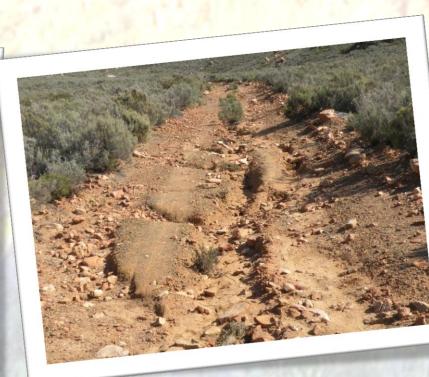
DCP test

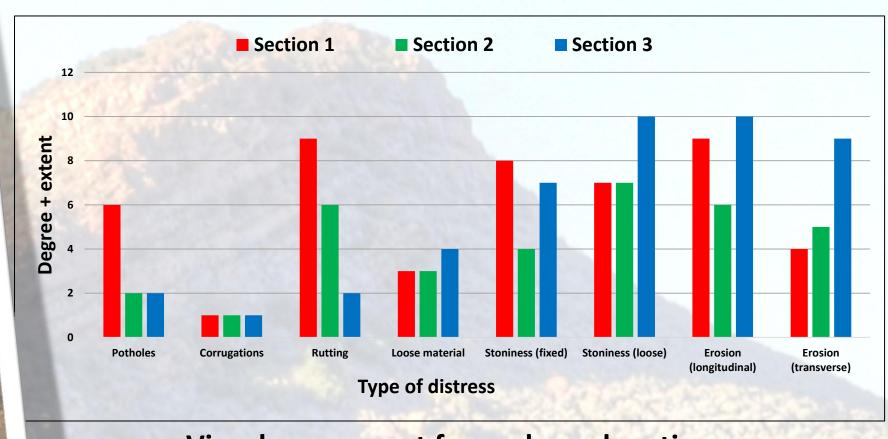
Visual assessment for each road section

The access road was divided into three sections. A visual assessment of the road was done to establish the major issues within each section. From the graph above it is evident that loose stones and longitudinal erosion are general problems, as well as excessive rutting in section 1 and transverse erosion in section 3. A total of 56 Dynamic Cone Penetrometer (DCP) tests were carried out in order to estimate the in-situ strength of the road material. After analysing the results, the California Bearing Ratio (CBR) was calculated for each test. The graph below shows the best and worst results for each of the three road sections.

The material comprising the access road is overall very hard with bedrock often encountered near the surface. It is recommended however that the road surface be filled up and compacted as water is currently unable to escape the road and causes eroded material to wash away. Furthermore, side drainage should receive special attention.

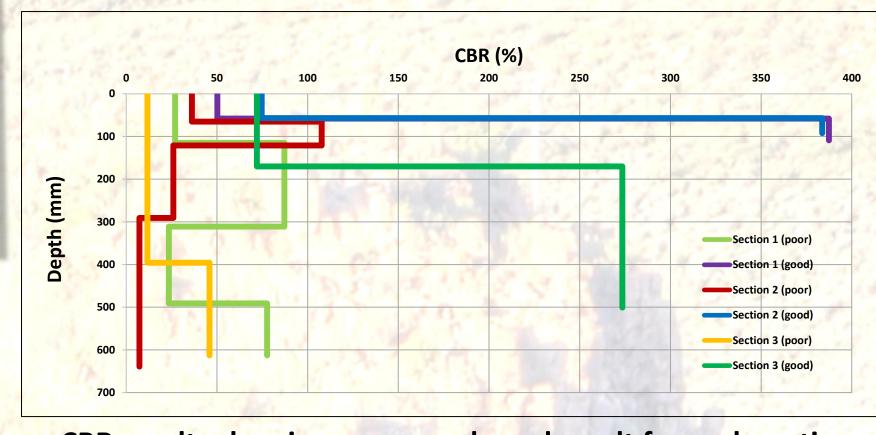
CBR results showing a poor and good result for each section
