ATLAS Tile Calorimeter Phase-II upgrade low-voltage power supply production and testing

Edward Nkadimeng, Ryan Mckenzie, Charles Sandrock, Roger van Rensburg, Othmane Mouane, Bruce Mellado

University of the Witwatersrand, ICPP

4 - 8 July 2022

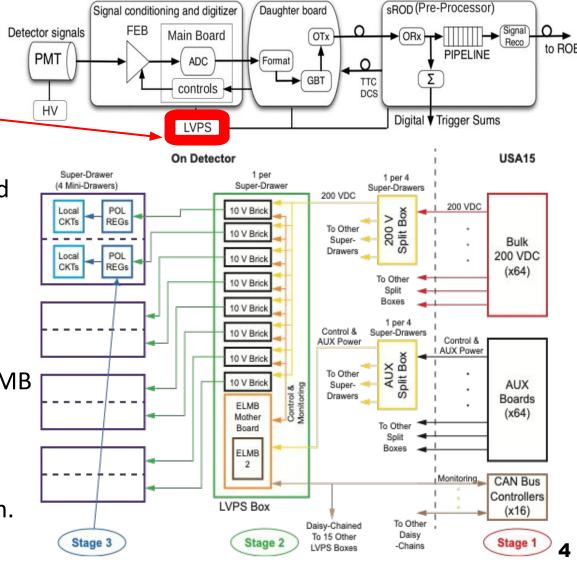
Power and Read out Architecture

- Upgrade from a **2-stage to 3-stage** power powering system distribution system to accommodate the FE upgrades.
 - Front-end power supplies all ± 10V _____
 - ☐ New: Point-of-load regulators
- ☐ Converts **200 V DC** to **10 V** DC to provide power to front-end electronics.
- All eight power supplies have the same specifications and performance requirements.
- LVPS monitoring system is still in progress but will utilize ELMB (**Embedded local monitoring board**) for control and monitoring of individual brick.
- LVPS's represent a **single point failure** in the readout system. i.e. loss of data from a module.

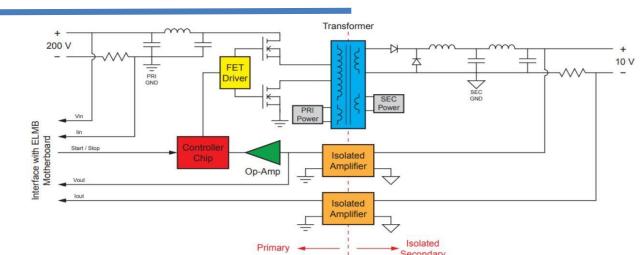
Brick principle of operation

- Transformer coupled buck convertor (Forward converter).
- Controller chip LT1681 (Heart of design) is used to provide switching at frequency of ~ 300 kHz

- Opto-Isolators: Provide voltage feedback.
- Shunt Resistor: For measuring the output current.
- Protection circuitry: Overcurrent Protection, Over Voltage Protection, Over Temperature Protection.

Parameter	Value		
Threshold for Stable Load	< 2 A		
Over Voltage Protection	11.5 – 12.5 V		
Overcurrent Protection	6.75 – 10.75 A		
Output Voltage Ripple @ NL	< 0.5 V (p2p)		
Duty Cycle @ NL	30 – 40 %		
Frequency @ NL	280 – 320 kHz		
Efficiency @ NL	> 65%		
Input Power (Current) @ NL	48 W (0.24 A)		
Output Voltage Change	< 20 mV/A		
Over Temperature Protection	70 Degrees C

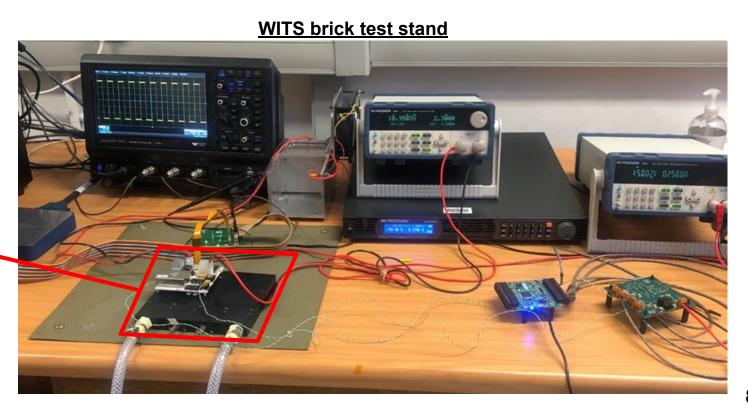
HE brick on cooling plate

- Test setup comprises of a single brick test stand running on one cooling plate coupled by custom temperature test set up to monitor the temperature of the components on top of the case to observe component characteristics as they vary with temperature.
- ☐ Test bench based on computer controlling and reading out equipment which perform the tests in LabVIEW

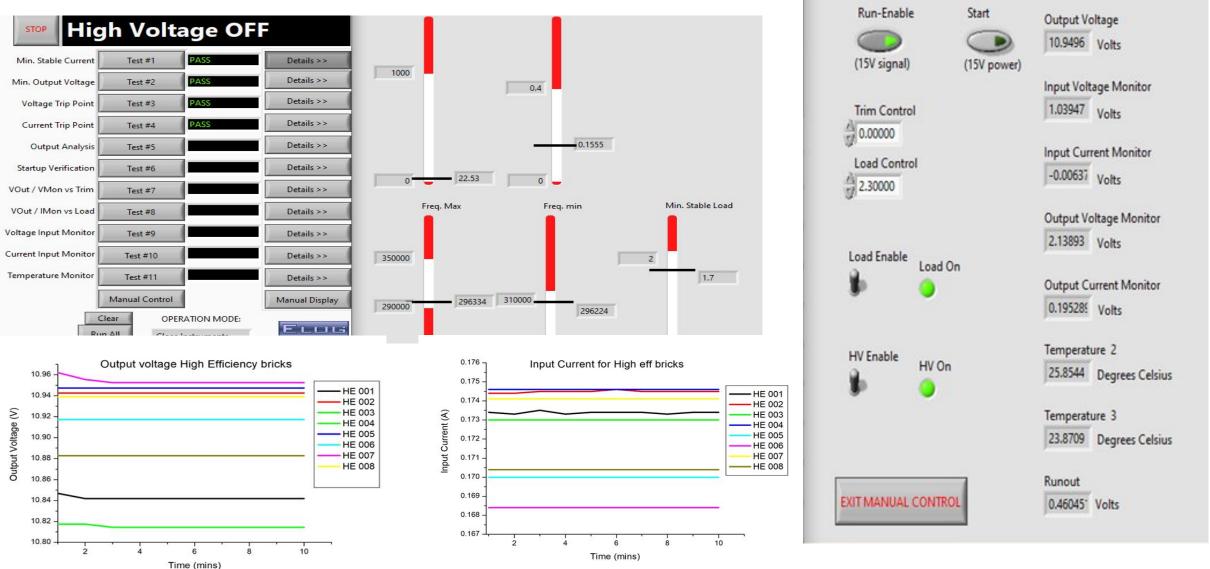
☐ Bricks were tested and monitored for ~15 minutes on 18/19 Sept '21, and all 8 bricks managed to start

without issues.

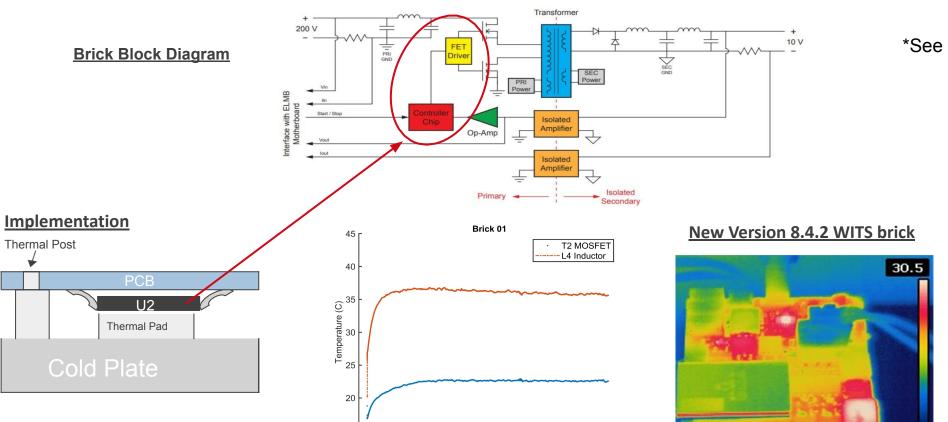
- *⇒* The symptoms:
 - Brick experienced high temperatures during operation
 - U1 (controller chip) & U2 (FET driver) had high failure rates

- *⇒* A possible cause:
 - Insufficient thermal coupling to cold plate
- ⇒ What we did:
 - New Higher efficiency MOSFET used (To be rad validated). Locally produced Al2O3 (aluminum oxide) ceramic cylinders used

- Add thermal Bergquist (Gap Pad) to couple chips to cold plate

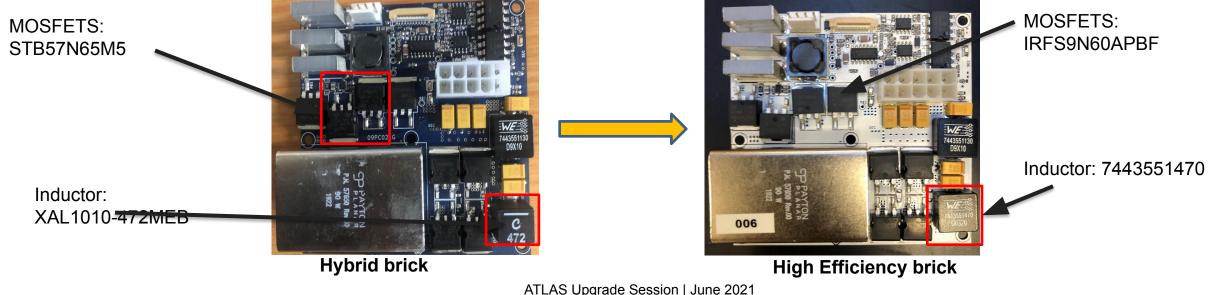
Latest brick production at WITS

- PCB design v8.4.2 was used for the latest round of eight (8) bricks populated in SA.
- Design changes include a different output inductor (736-2037, Wurth, WE-HCI,) and different MOSFET (RFS9N60APBF) as was identified in thermal testing undertaken at CERN, showed a brick efficiency increase from 55-60 % to 68-75%. (component still to be rad certified!)
- 14 thermal posts per brick used for heat transfer from components to the cold plate from which 8 are metalized and 6 non-metalized. For the latest iteration eight (8) bricks populated using purely Al2O3 ceramic cylinders.

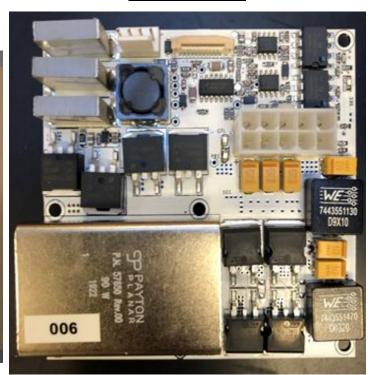
LVPS brick

Ceramic posts

Ordered 15000, PO issued

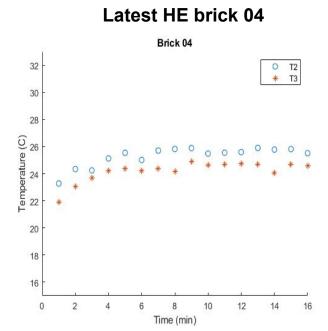
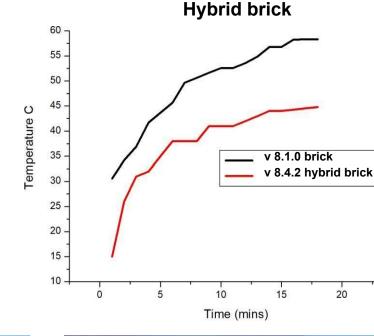
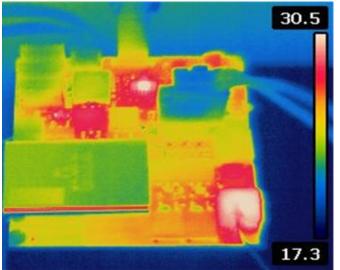
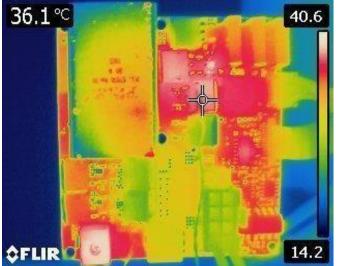
LVPS Thermal results

- □ Temperature 2 and 3 data measured every minute interval from available brick thermistors.
- □ Preliminary temperature results using new high efficiency MOSFET show a significant temperature reduction in all bricks by almost ~10 °C.

Avg Temp 2 ~ 50.4°C and Temp 3 ~ 39.1 °C

Avg Temp 2 ~ 38.2°C and Temp 3 ~ 31.1 °C

Avg Temp 2 ~ 27.2-29.0°C and Temp 3 ~ 24.1-27°C

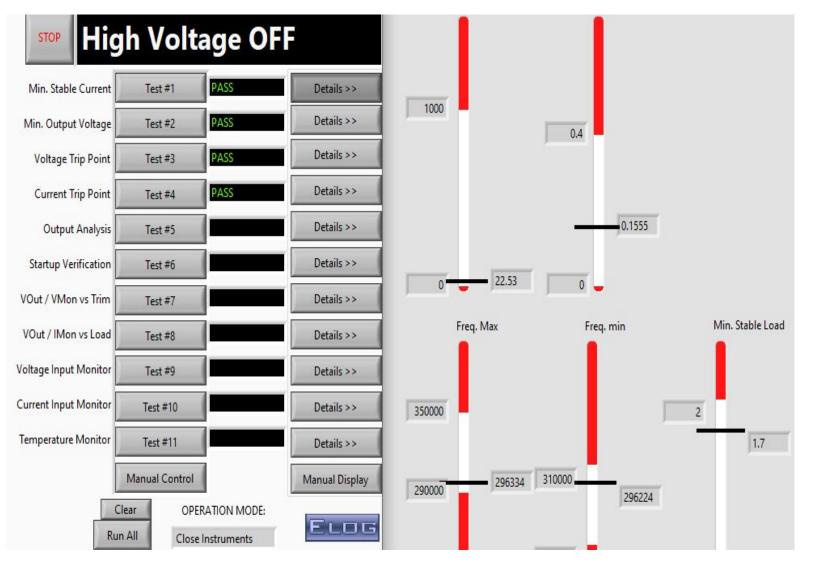
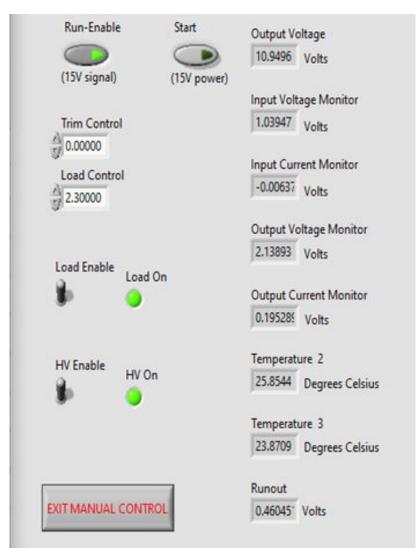
■ Bricks were tested and monitored for ~15 minutes on 18/19 May '21, and all 8 bricks managed to start without issues.

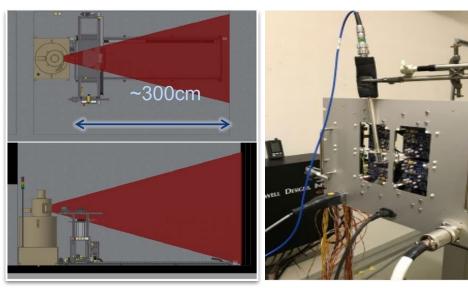
- ☐ We tested 8 bricks up to a target dose of close to 500 Gy.
- All the 8 bricks were running monitoring during up to end of the tests with only an output voltage drop of 1 mV/Gy.
- This drop is completely acceptable due to wide range of input voltage for our front end electronics.
- Parameters show expected behaviour as a function of time.

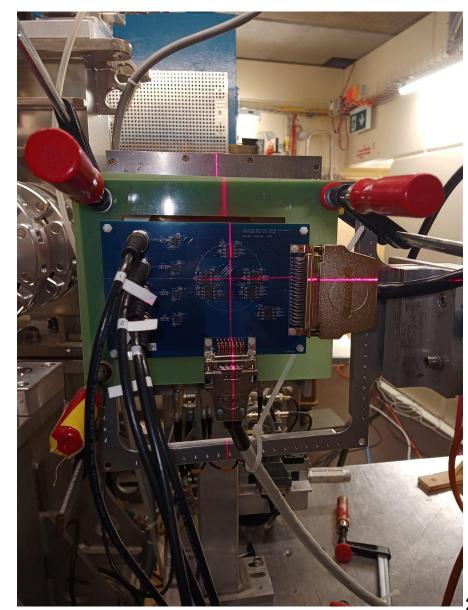
Experimental set-up: Component-Level tests

- The tests were performed with **200 MeV** proton beam with a flux of $3.5 \times 10^8 \text{ p/cm}^2/\text{s}$
- Each board was tested for around 30 minutes to reach 6.47 x 10^{11} p/cm² (equivalent to 400 Gy)
- ☐ The chip has a fixed gain of 8.1, and by setting an input voltage of 0.15 V on all the chips, we expected to have an output voltage of 1.22 V
- All the 11 output voltages were being read by DAQ, and the output voltages of two of the chips (Chip #2 and Chip #10) were connected to a scope to see possible SETs.
- ☐ The result will only focus on the SI8920 Isolation amplifier

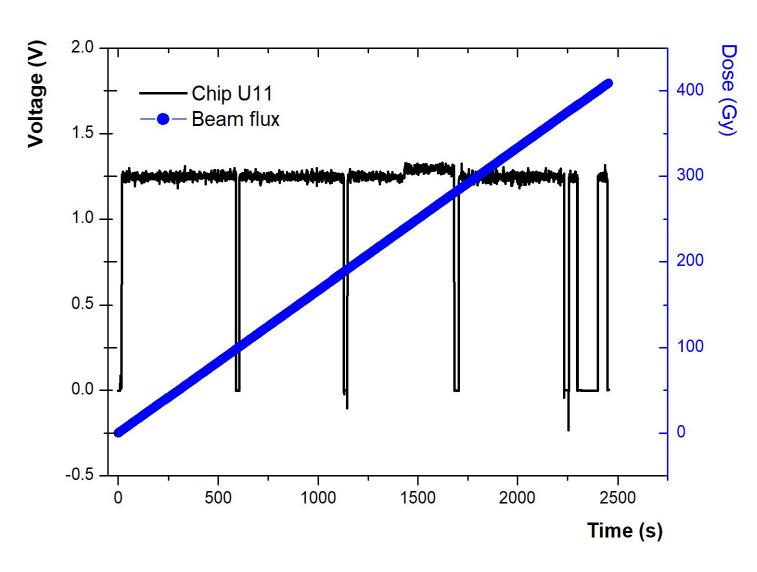
- The tests were performed in 4 runs, and there were a power cycle between each two consecutive runs
- There were also two power cycles at the end of the tests, just to see if any of the faulty chips will behave correctly after power cycle, or if any working chip will continue to work
- ☐ The results from the reference chip (chip #11) shows that this chip behaved completely normal during the test

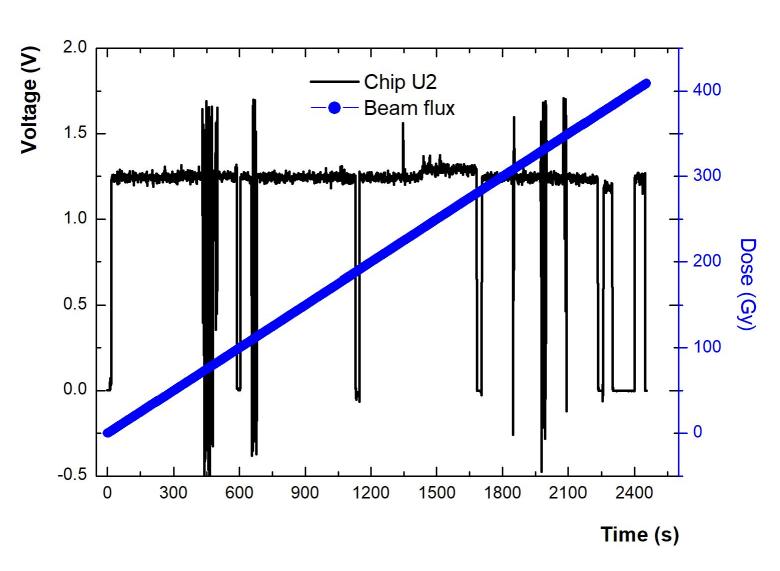
- The results from Chip #2 show that this chip almost behaved like the reference chip during the whole test, except for some time during the first, second and fourth runs, where it showed some fluctuations
- ☐ The fluctuations from Chip #2 went away without a need to power cycle
- ☐ The chip also survived the test after receiving 400 Gy

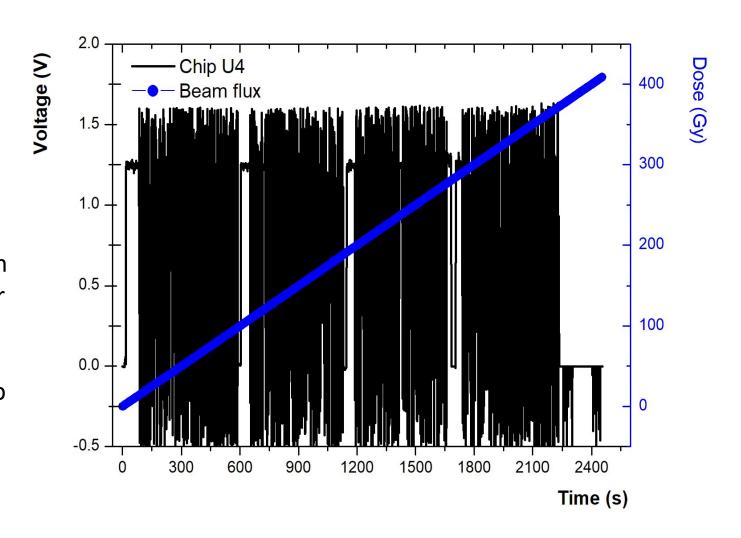
- ☐ The results from Chip #4 show that in all of the 5 runs, it goes to an unstable mode, where the output voltage fluctuates a lot
- The fluctuations started almost at the beginning of each run
- The fluctuations did not stop when the beam was stopped at the end of each run (a power cycle was needed)
- After the last run (receiving 400 Gy), the chip stopped working properly (due to TID effects), and even the two power cycles did not fix the issue

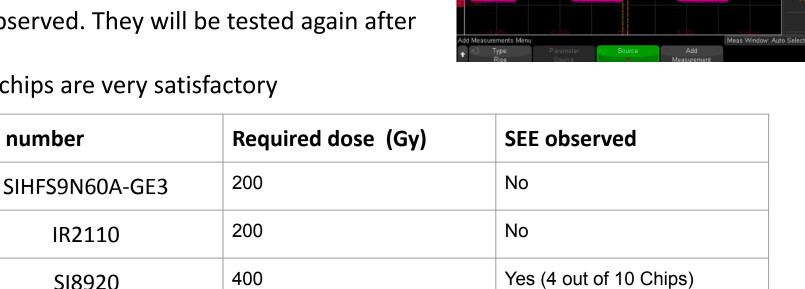
The MOSFETs were tested for SEEs by connecting the gate to source, and looking for transients on the drain

- No SEEs were observed
- The chips still has to be tested for characterization after they are back from PSI

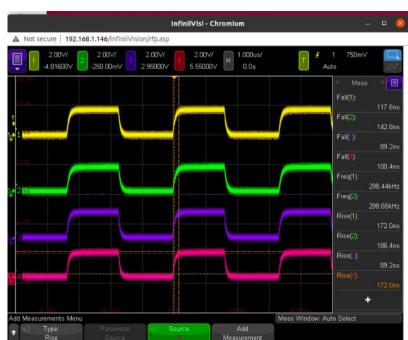
The MOSFET drivers were tested for SEEs and for any possible drift in pulse shapes

No SEEs or possible drifts were observed. They will be tested again after arriving at CERN
