Characterization of damage in in-situ radiated plastic scintillators at the Tile calorimeter of the ATLAS

Abstract. Ukrainian Polystyrene-based plastic scintillator (UPS923A) samples manufactured by the Institute of Scintillating materials in Ukraine were investigated using Raman scattering techniques. Three irradiated samples of the same type (UPS923A) from the Minimum Bias Trigger scintillator (MBTS) taken from three different positions: Top (T1), Bottom 1 (B1) and Bottom 2 (B2) in the ATLAS detector were investigated. And compared to an un-irradiated sample (D1) of the same type and a 40 MegaGy UPS923A irradiated sample. The aim of this investigative project was to understand how the molecular structures of plastic scintillators are damaged due to high energy collisions at LHC using Raman scattering techniques. It was also to observe if there are any variations in the molecular damage of the plastic at different positions in the MBTS. It was found that the Raman spectra of the irradiated samples at three different positions in MBTS are similar in shape and have similar peaks, thus the extent of the molecular damage at this positions is not easily distinguishable between the sam

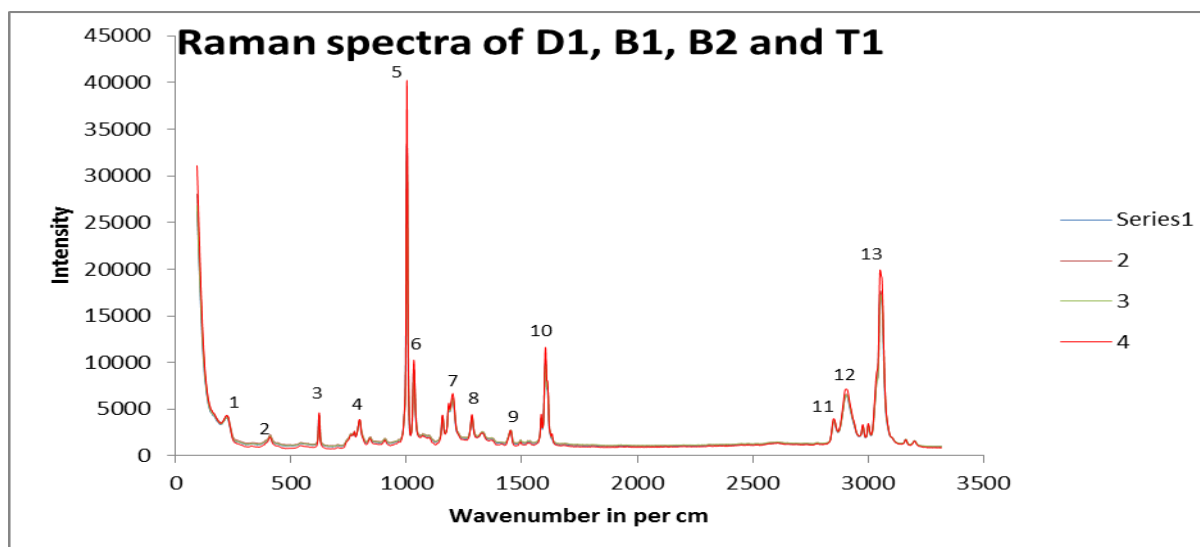
Figure 1. Raman spectra of all irradiated sample from the Tile calorimeter compared to an equivalent un-irradiated sample (see text).

Red represents D1 (un-irradiated sample), Brown represents B2 (2nd bottom irradiated sample), Green represents T1 (top irradiated sample) and Blue represent B1 (bottom irradiated sample). Figure 1 shows the Raman spectra of the irradiated samples and those spectra have numbered peaks intensities which are defined in Table 1.

Using Figure 1, it can be argued that the spectrum of each sample in the MBTS detector, at each position: 1st bottom (B1), 2nd bottom (B2) and top (T1) irradiated samples have similar Raman spectra shape as the Raman spectra of un-irradiated D1 sample. All these samples have 13 peaks in their Raman spectra. It is also noted that the peaks intensities for D1 un-irradiated sample Raman spectrum are larger than that of the irradiated samples, which suggest that some bonds in the plastic scintillator before irradiation were broken.

It can be noted that the molecular structure of irradiated samples and the un-irradiated sample compared is the same. Thus the peaks of D1, B1, B2 and T1 have the same wavenumber and therefore have the same functional group in each sample. But the intensities of the peaks for each irradiated samples are different from the intensities of the un-irradiated sample. Looking at Figure 3, it can be seen that peak 2 of D1 has smaller intensity compared to peak 2 of B1, B2 and T1, which suggest that the irradiated samples have more δ (CC) aliphatic chains compared to the un-irradiated sample.

Looking at peak 5, it can be seen that the intensity of this peak in D1 is very high compared to intensities of the same peak in the irradiated samples. These suggest that there is a depletion of ν (CC) aromatic ring chains after irradiation, thus bonds were broken in the benzene ring. But when B1, B2 and T1 are compared to each other, it is noted that radiation damage is not constant in MBTS detector since their peak intensities are not equal (see Figure 3).

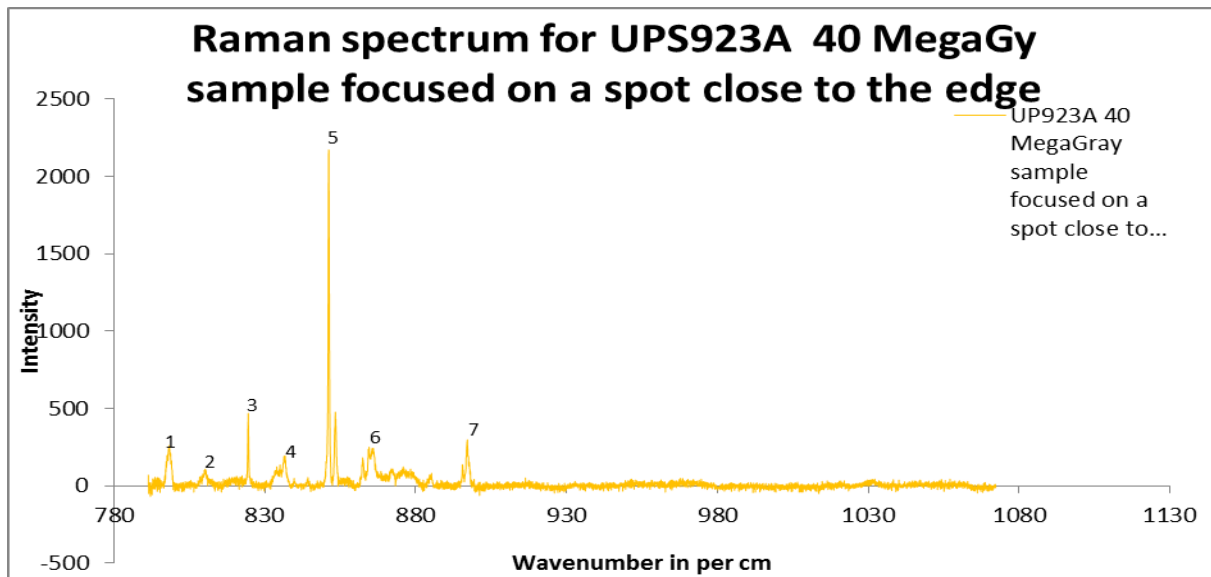
Figure 2. Raman spectrum for UPS923A 40 MegaGy sample.

Using Figure 2, it can be noted that the Raman spectrum of UPS923A 40 MegaGy sample is different from the other Raman spectra of the samples from MBTS detector. Again using Figure 2, it can be seen that all the peaks in the Raman spectra ranges from 700-900 cm^{-1} . This region corresponds to the ν (CC) alicyclic, aliphatic chains vibrations region when using Horiba Raman band analysis (refer to [4] and Table 1) for comparison. This suggests that the benzene ring was completely destroyed, thus that the material was extensively damaged by radiation. This also tells us that as the radiation dose is increased, radiation damage increases, thus more bonds are destroyed in the molecular structure of the plastic scintillator.

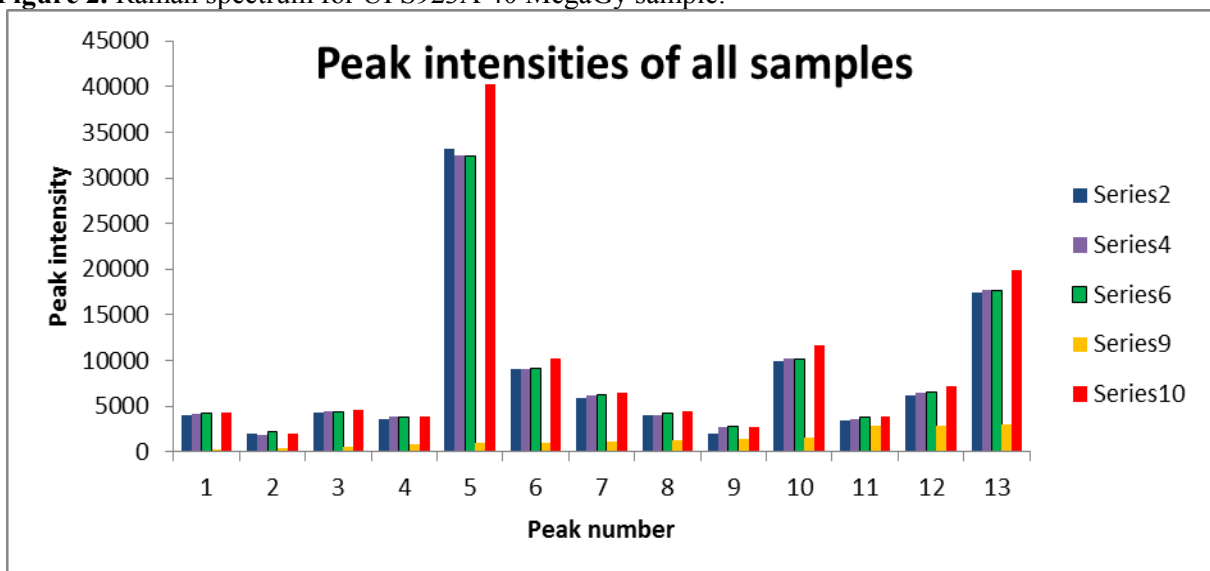
Figure 3. Compared peak intensities of all samples (see text).

Red represent D1 (un-irradiated sample), Blue represent B1 (1st bottom irradiated sample), Purple represent T1 (top irradiated sample) and Orange represent 40 MegaGy irradiated sample.

It can be noted that the peaks intensities of B1, B2 and T1 are not the same, which suggest that radiation damage in the MBTS detector is not constant; it depends on where the plastic scintillator is located. According to Figure 3, the bottom sample (B1 and B2) was damaged more than the top (T1) sample plastic scintillator from MBTS detector. It can be noted that the peak intensities for peak 1,2,3,4,6,7,8,9,10,11,12,13 of B1 are smaller than those of T1 and B2. These suggest that the radiation damage in B1 is greater than the radiation damage of the same type of plastic scintillator at position B2 in MBTS detector.
