Introduction

- Thermal infrared (TIR) images of operational photovoltaic (PV) modules are generally misinterpreted because of the dynamic nature of some types of soiling.
- TIR imaging is ideally conducted under steady climatic conditions, however under dynamic operational conditions different TIR images are observed.
- Wind blown dust is dynamic in nature and can settle on the bottom rows of PV modules.
- Cell anomalies, partial soiling and defective cells, can cause current mismatch in crystalline silicon PV modules and create hot spots which can be detected on TIR images.
- Mismatched cells impact on performance and longevity of PV modules.

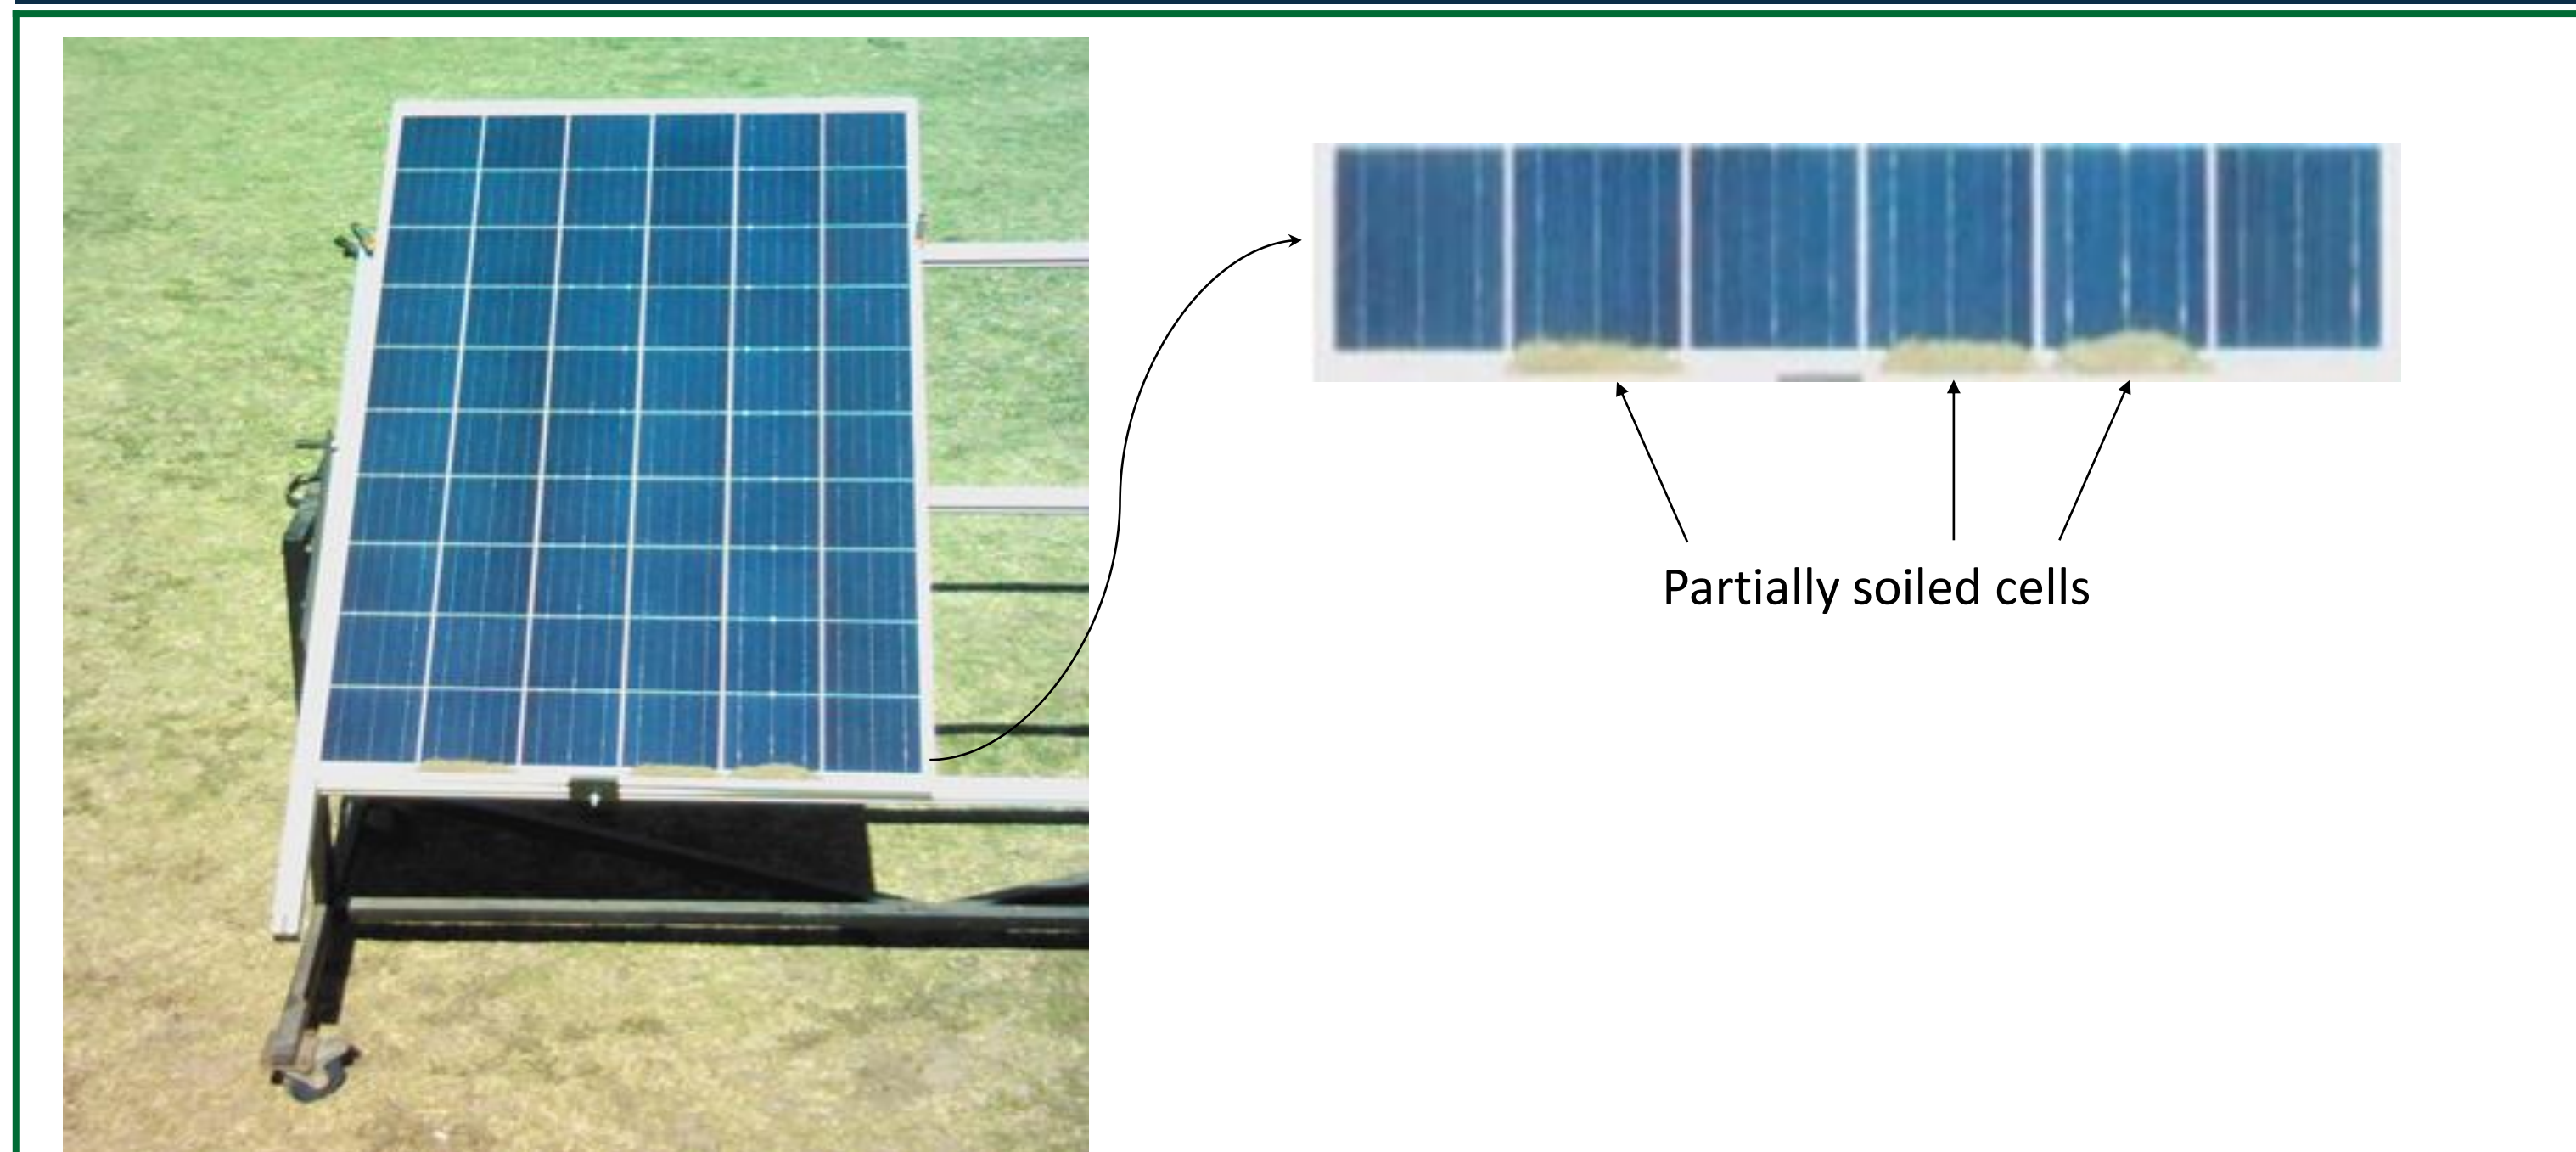
Fig 1: Soiled crystalline silicon PV module inclined for TIR imaging and I-V measurements.

- Crystalline silicon PV module set up to receive irradiance of more than 1000 W.m⁻².
- TIR images were recorded when the module was unsoiled and when three cells in different substrings were partially (<10%) soiled sequentially, while under short circuit conditions.
- Current-Voltage (I-V) measurements were taken for the soiled and unsoiled scenarios.
- Electroluminescence (EL) imaging was conducted to check cell anomalies which were not visually identified.
- The testing techniques were also conducted on an array of monocrystalline PV modules.
